**RCRA SITE SCREENING INSPECTION REPORT**  
**Enforcement Confidential – Deliberative Process**

SITE NAME: Canton Drop Forge  
EPA ID NUMBER: OHD004465142  
ADDRESS: 4575 Southway Street S.W.  
Canton, Ohio 44706  
DATE OF INSPECTION: July 1, 2011  
EPA INSPECTOR: Michael Beedle

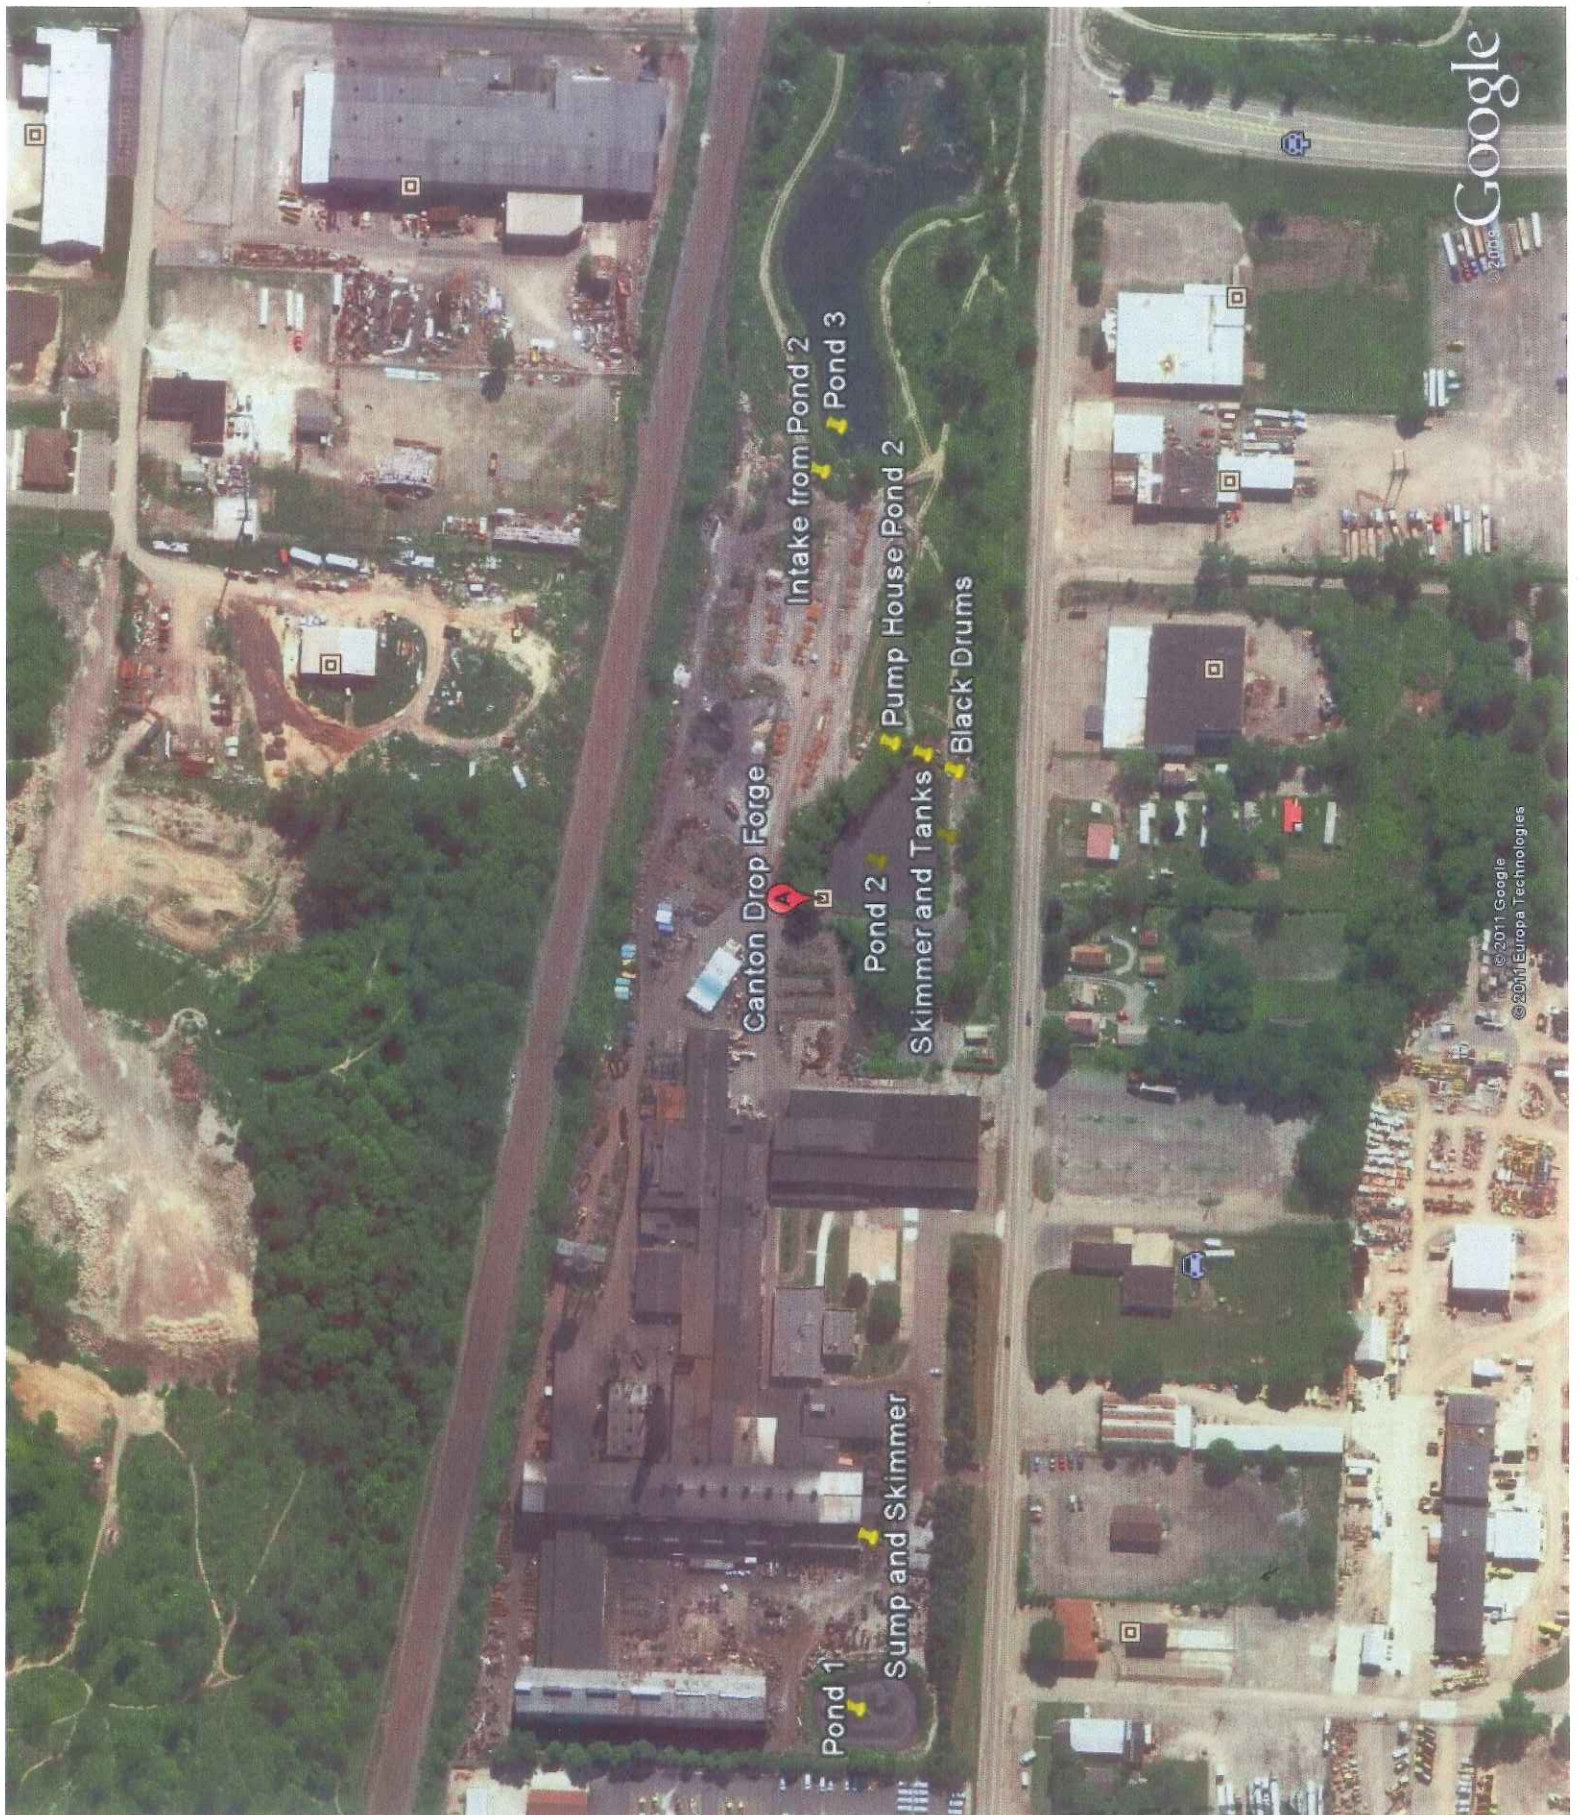
### **Annotated Aerial Photograph**

This inspection was a site screening inspection of Canton Drop Forge. This inspection was to determine if the site should be considered for full inspection. The site was identified for the screening inspection through a review of National Response Center (NRC) reports of releases in the Canton, Ohio, area. One report NRC received was for oiled geese. See Attachment A for this NRC report. Review of aerial photographs of area, where the geese were found, indicated that Canton Drop Forge had three surface impoundments. The aerial photographs indicated that two of the impoundments were dark in color, similar to other oily impoundments found at the WCI Steel matter. One of the impoundments appeared clean and clear of oil. See an annotated aerial photograph of the site in Attachment B.
